Home Energy Efficiency Report

Property Address: **132 Van Ness Street**

Date of Site Visit to Property: **July 9, 2009**

Site Visit and Report by: **Sharon Block**, CHEERS® Certified Existing Home Analyst,
HERS Whole House Energy Rater, Certified GreenPoint® Rater, LEED AP and
Rick Meyer, CHEERS® Certified Existing Home Analyst

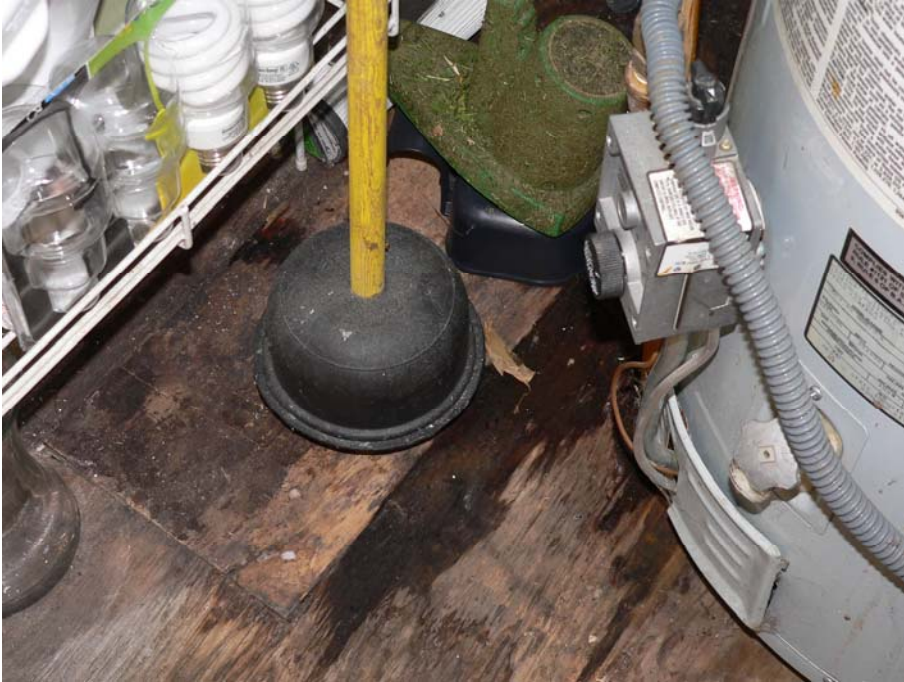
We noted substantial standing water under the water heater (see photo below) indicating a possible leak. While the water heater was running, there was a knocking sound, indicating the buildup of sediment and/or scale in the bottom of the tank. Leaking is usually a symptom of a failing water heater and knocking the sign of build up. When sediment from incoming water or scale from dissolved minerals builds up in the bottom of the tank, it acts as insulation causing the flame to be on for longer periods and the metal tank to get much hotter, reducing efficiency and causing early failure of the tank bottom.

If the water heater is only a few years old and this is a premature failure, it is likely caused by rapid build-up. To avoid premature failure of a new water heater, clean out sediment or scale periodically. You can examine the anode and access the bottom of the old water heater to determine the nature of the failure and predict what type of servicing will be needed for new one and whether sediment or scale is the main problem. You should also replace the sacrificial anode when necessary. The standing water in the water heater closet will rot or is already rotting wood, and the leak will worsen with time.

Water under and behind water heater in cottage. Probable leaking water heater.

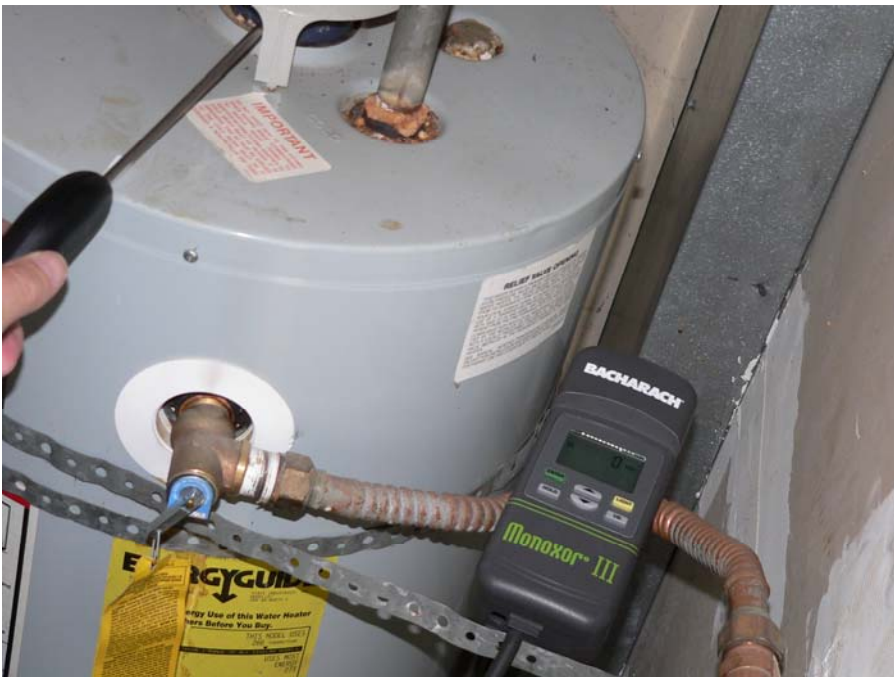
We noted 10 ppm CO in the water heater flue gas indicating good, complete combustion, but also 2 ppm in the water heater closet. This is not a dangerous level, but it is possible that flue gas is escaping from gaps in the flue pipe or that the pipe is obstructed. We recommend that these issues be checked carefully when the water heater is serviced or replaced.

Measuring carbon monoxide content of cottage water heater flue gas.
The reading was low, which is good.

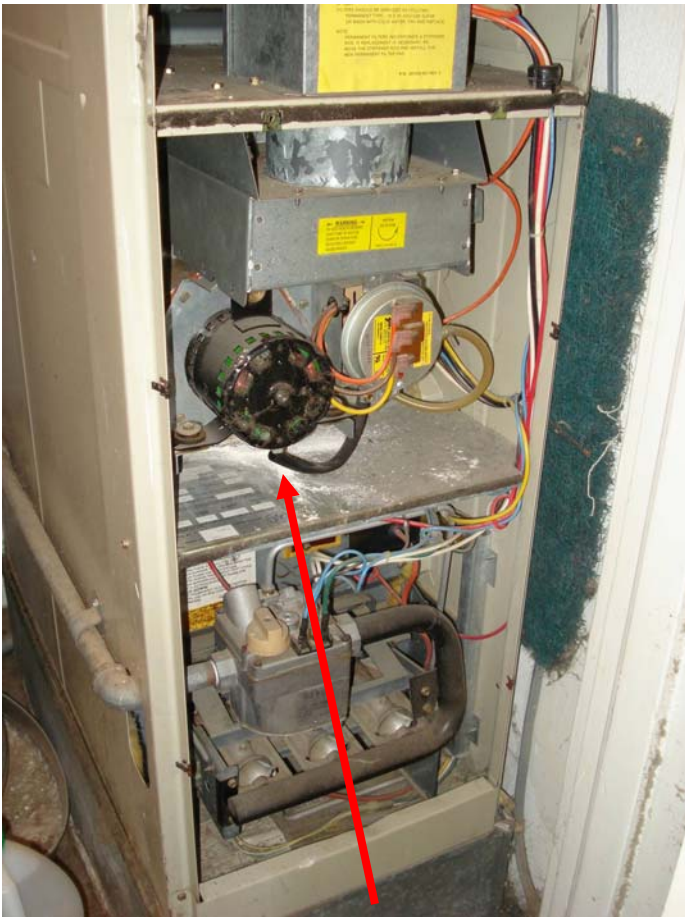
We noted corrosion on the furnace motor (see photo) and on the cold water intake to the water heater, indicating persistent indoor moisture. You reported mildew in the TV room. We measured a relative humidity indoors of 58% indoors and 48% outdoors. Because the temperatures were almost the same indoors and outdoors, no adjustment is needed and so these figures represent significantly more moisture in the indoor air than the outdoor air. You told us that there were no recent activities indoors that could have temporarily elevated the humidity.

White powder below motor appears to be some type of corrosion indicating possible excessive moisture.

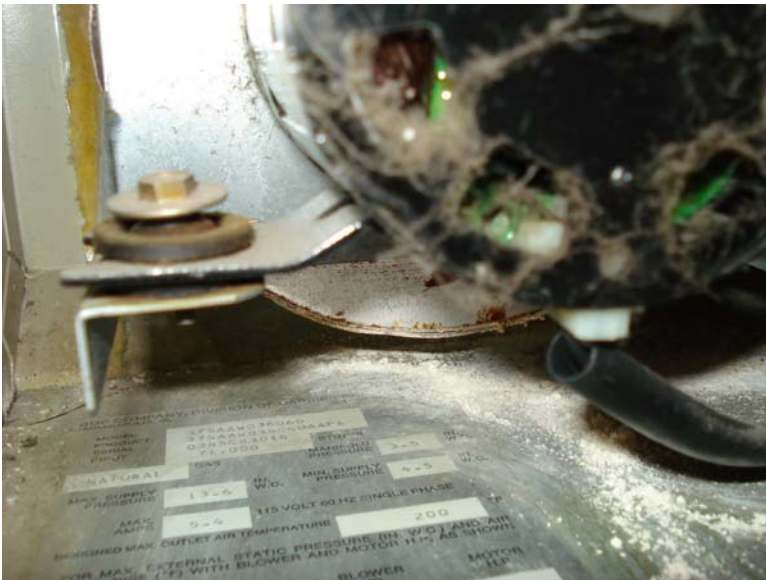
Close up of the same corrosion.

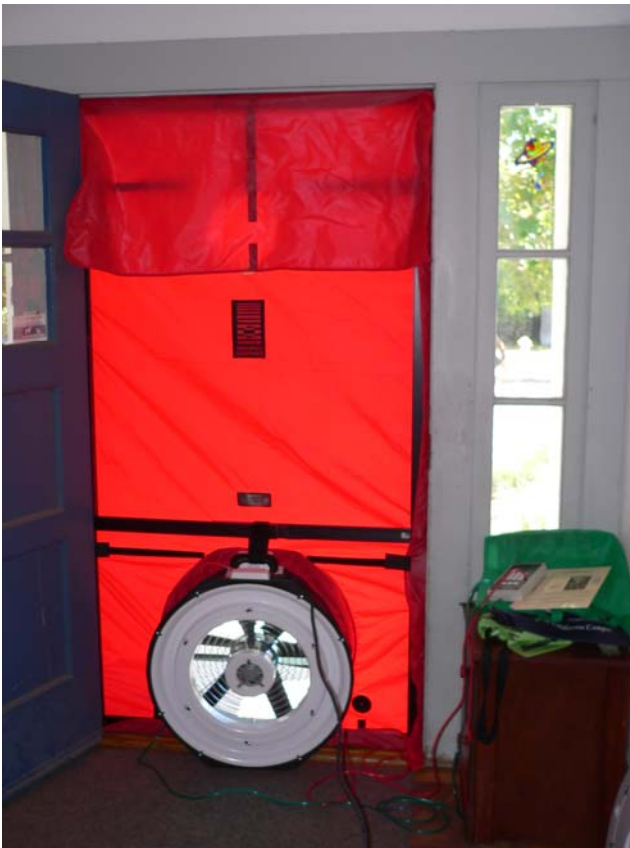
Our tests revealed that your home's envelope is "leaky". Your home's envelope consists of the exterior walls, floors and ceiling that hold air inside. Total envelope leakage was 4450 cubic feet per minute measured at a pressure of 50 pascals (4450 CFM₅₀), which is much more than the leakage needed for healthy ventilation. Under typical conditions in our climate zone, this would amount to 212 CFM_{nat} of natural ventilation (4450 CFM₅₀/ 21 N_{LBL} = 212 CFM_{nat}). The required healthy airflow is only approximately 79 CFM_{nat} (1700 square feet CFA * 8 foot ceilings = 13,600 cubic feet * .35 air changes per hour = 4760 cubic feet per hour = 79 CFM_{nat}). In other words air you are paying to heat is escaping at nearly three times (212 / 79 = 2.7) the rate that is needed to provide healthy ventilation. If we added together all the leaks in your house, most of which are hidden, they would equal to having a window open all the time, with an open area equivalent to 2.6 sheets of copy

Blower door test in process. We noted a high level of envelope leakage.

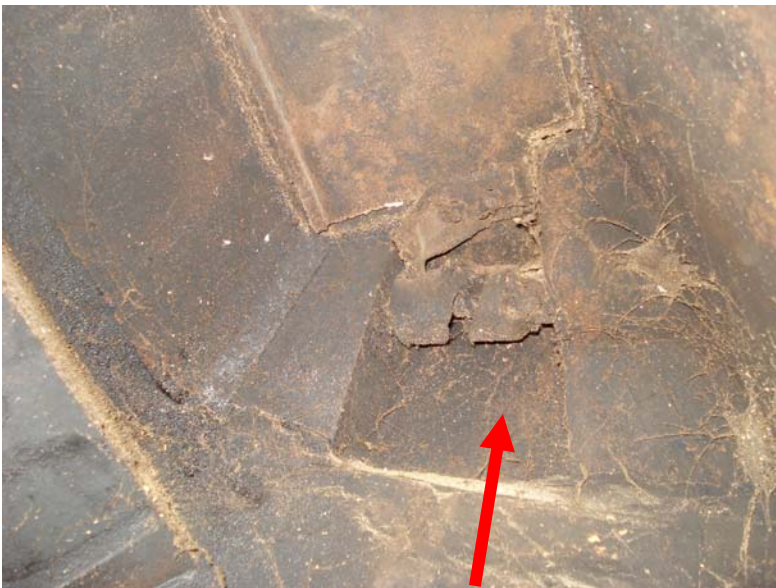
Damper in fireplace has large “holes” and was a significant source of air leakage.

We noted leakage around the fireplace damper. Rather than replace the current damper, for which an exact replacement is probably unavailable, consider adding a new damper in a different location. You may find ideas for tight-sealing dampers at www.chimneysupply.com. Bear in mind that there are codes that require the fireplace flues extend a certain height above the roof.

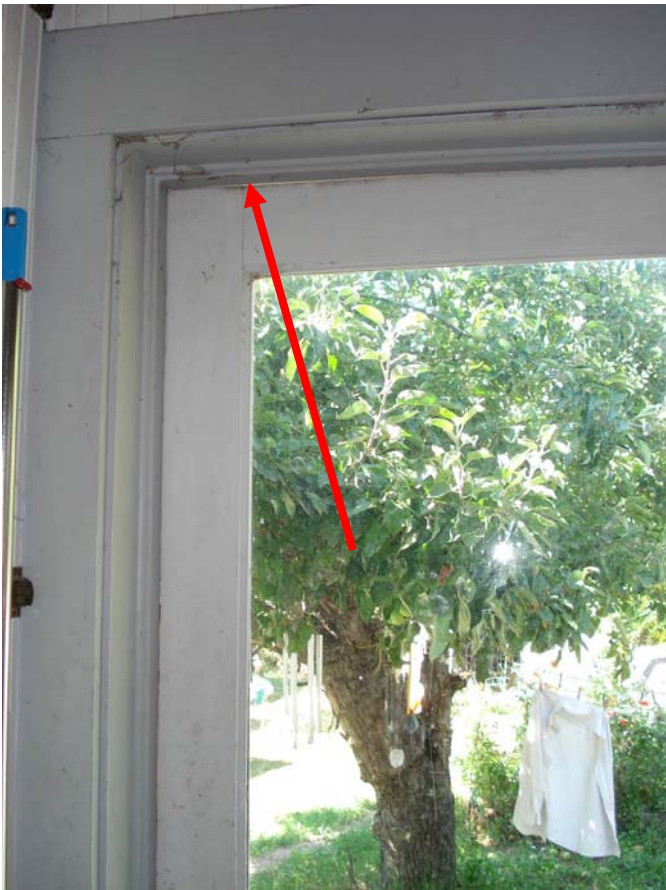
Back door doesn't seal well. Large gap at upper left corner

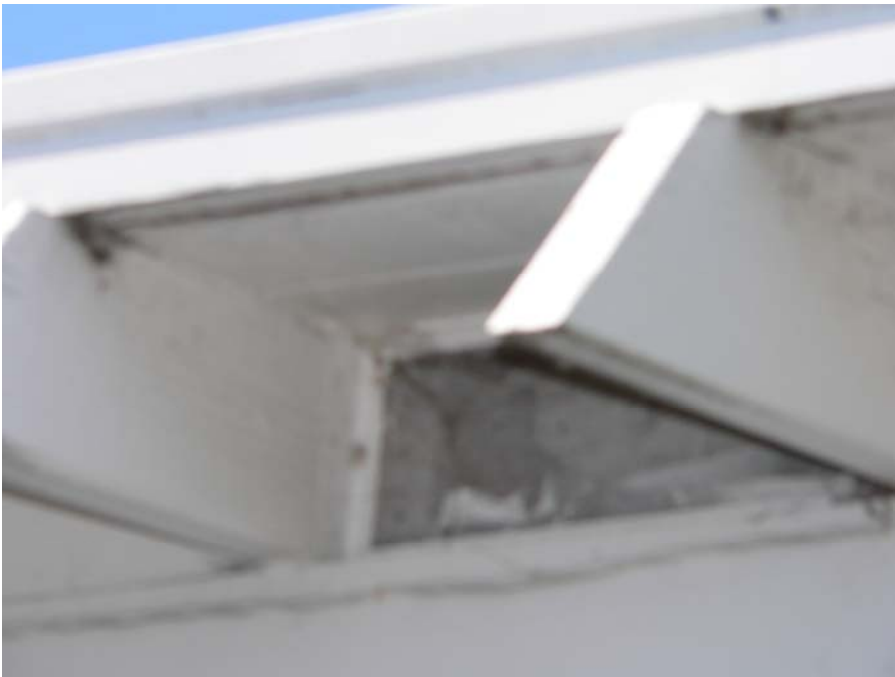
Looking for insulation in cottage attic from outside since attic hatch inside was inaccessible. Result inconclusive.

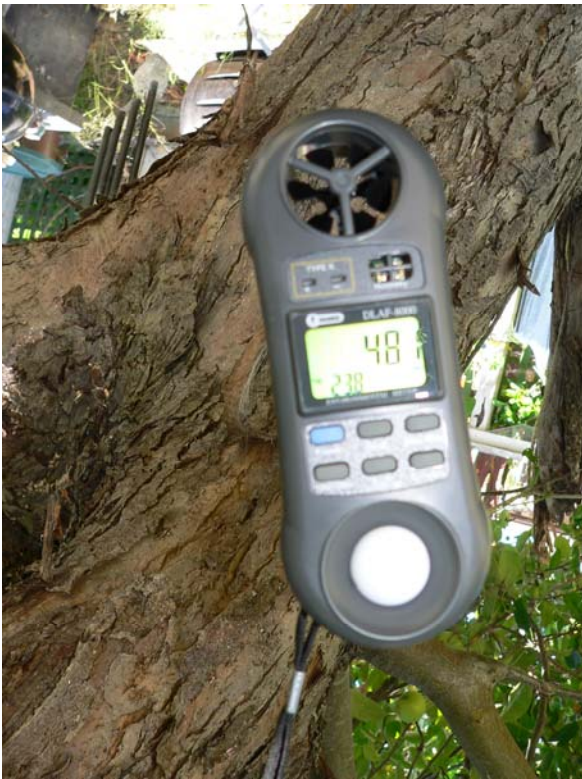
Measuring outdoor relative humidity. It was significantly lower than indoor humidity.

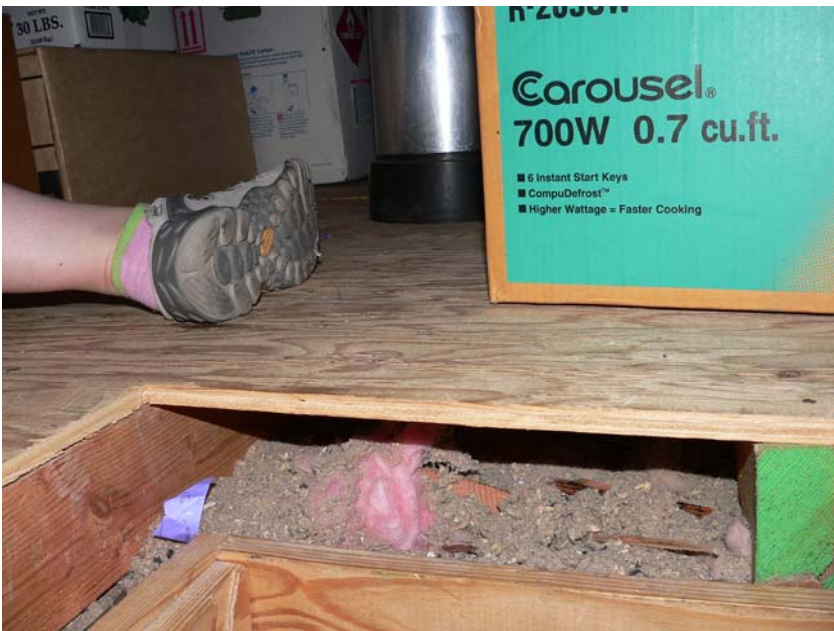
We have determined through our inspection that the insulation in your attic is only about 3 inches deep and is a mixture of fiberglass and cellulose (see photo). It is likely to have an R value of only 11-13. You may consider adding blown cellulose insulation to increase the total R value to 30, about 10 inches deep, the current recommended level. We recommend sealing the envelope (see below) before insulating, so that the added insulation does not cover up areas that need sealing. We noted some old knob and tube wiring in the crawl space – if any of it is still active in areas to be insulated, consult with an electrician. The National Electric Code forbids the installation of loose, rolled, or foam-in-place insulation around knob and tube wiring.

Insulation in the attic is only about 3" thick.

Typically an insulation contractor will recommend that blown loose cellulose or fiberglass be added. The insulation contractor must make sure that the attic will still be well ventilated after the insulation job. This may involve adding baffles near roof vents in the eaves/soffits prior to “blowing” the insulation to prevent vents from being blocked by the added insulation. The insulation contractor should insulate the hatch or fold down stairs to the attic with foam board and seal it with weather-stripping or a gasket. If you want to reinstall the floor after insulation is added, it would be necessary to remove the plywood flooring and add deeper ceiling

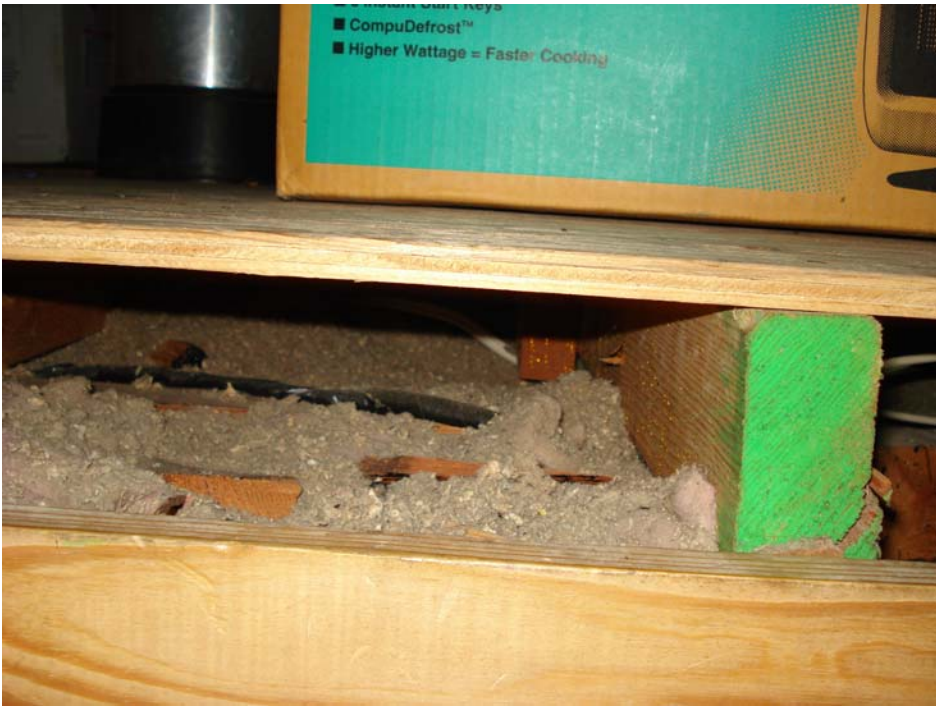
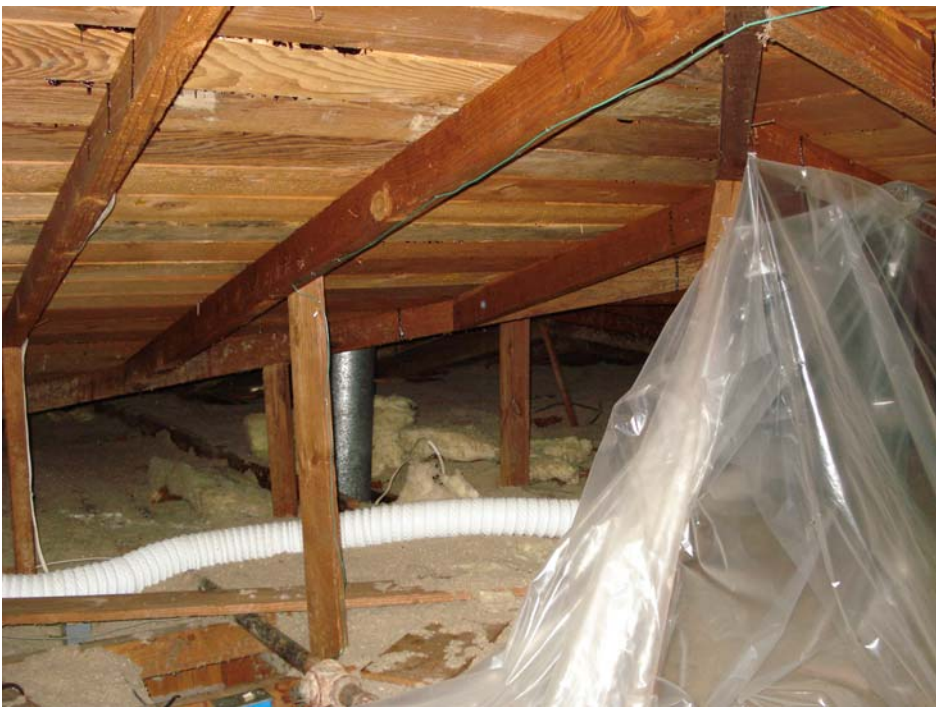
We recommend removing the plastic that covers the attic insulation to prevent the trapping of moisture.

joists before blowing in insulation, so that the deep insulation does not cover up the tops of the joists and they can support the floor again. Blowing in new attic insulation is usually a cost effective measure. There was plastic laid over the insulation which may capture moisture in the insulation, thereby degrading the R-value. We would recommend removing the plastic.

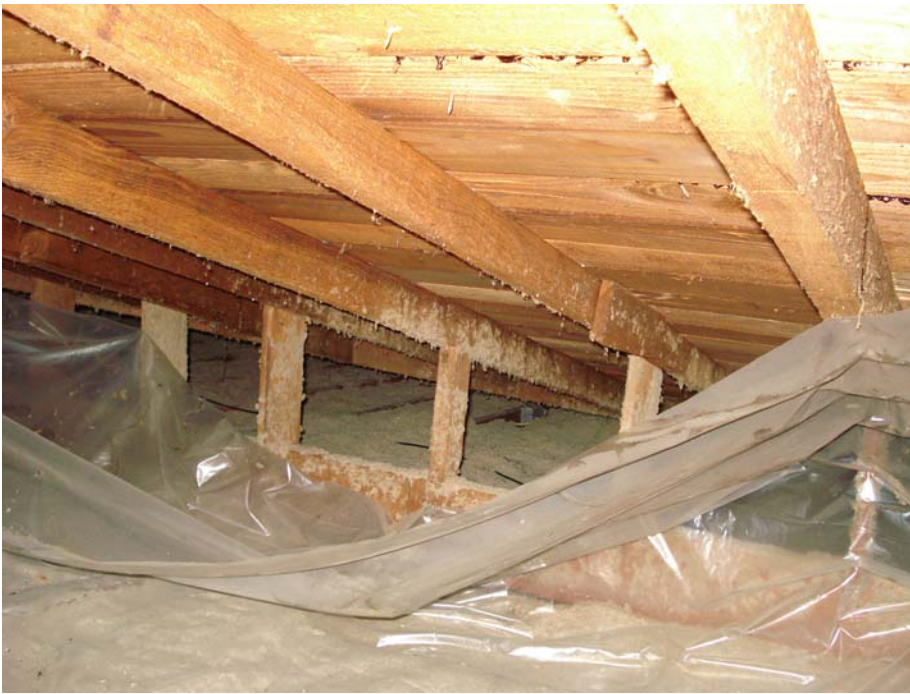
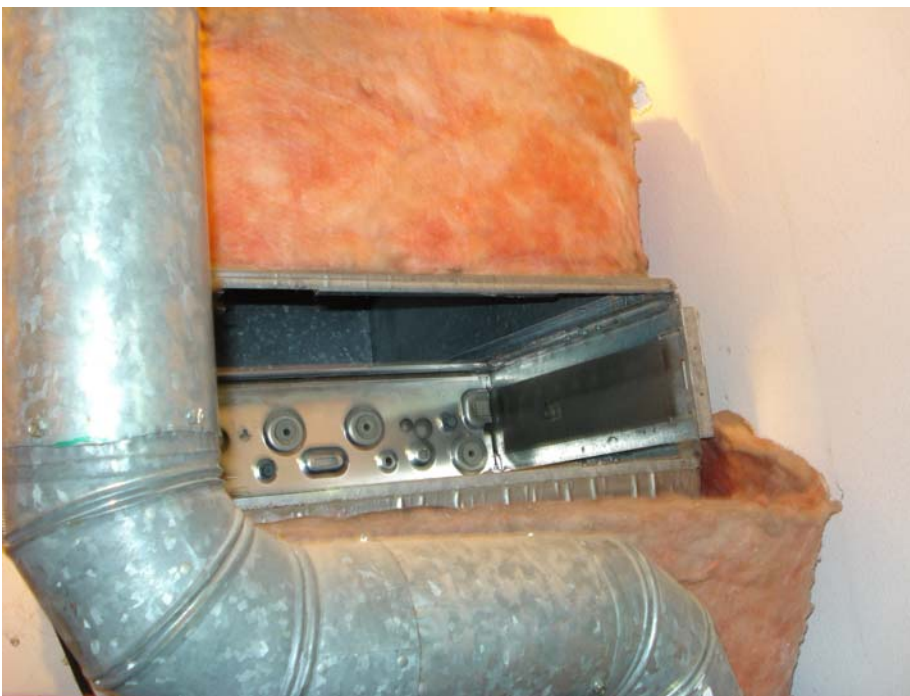
Electrostatic cleaner in furnace. The filter was dirty.

We removed the metal mesh and electrostatic filters from the furnace to conduct the blower door test. We noted that both were dirty. This condition reduces their effectiveness at filtering dust and also impedes airflow, reducing the efficiency of the furnace. We recommend obtaining a supply of filters and replacing them every few months as soon as they becomes dirty, and at least annually. We also recommend cleaning the electrostatic filter per the manufacturer's recommendations at the same time.

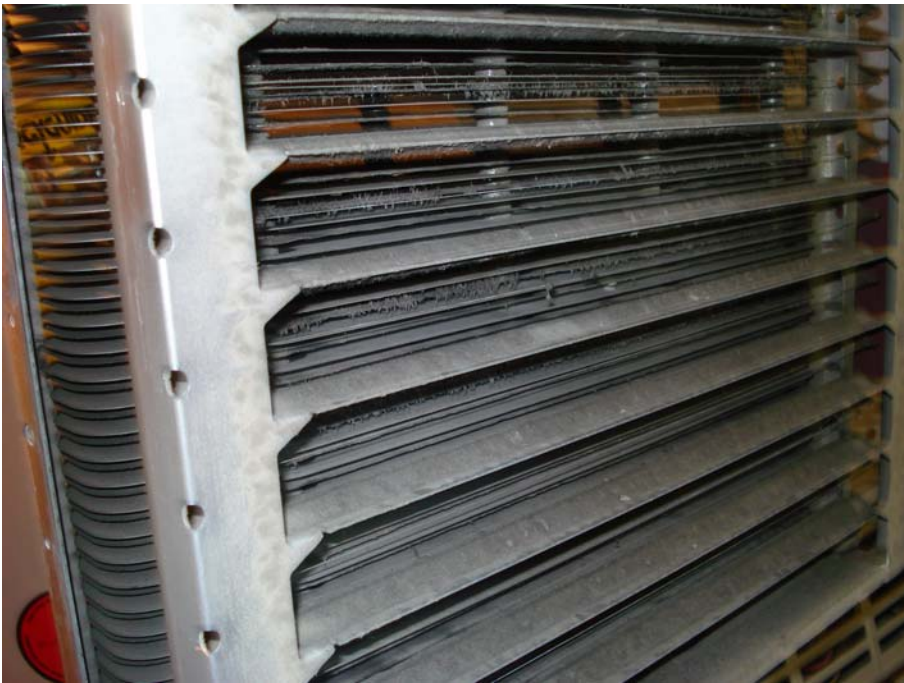
Dirty electrostatic filter close-up.

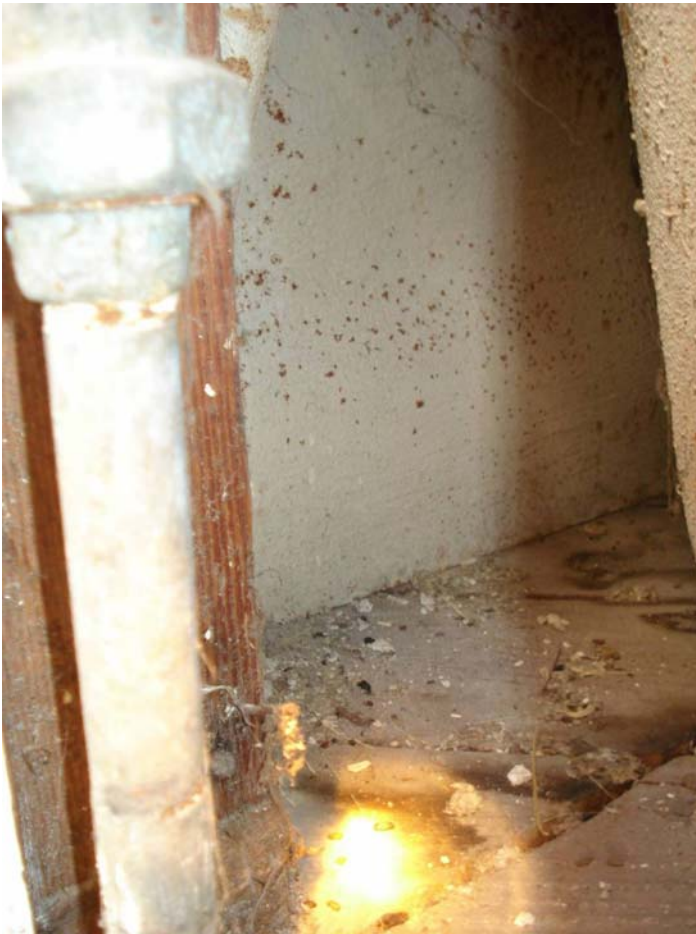
In our inspection of a small outdoor access door in the main house that reveals the plumbing to the bathtub, we noted mouse droppings. We recommend sealing all holes and cracks that could allow pests into the crawl space with urethane foam or caulking, while preserving the existing screened vents.

Wall behind tub from exterior. Some rodent droppings found.

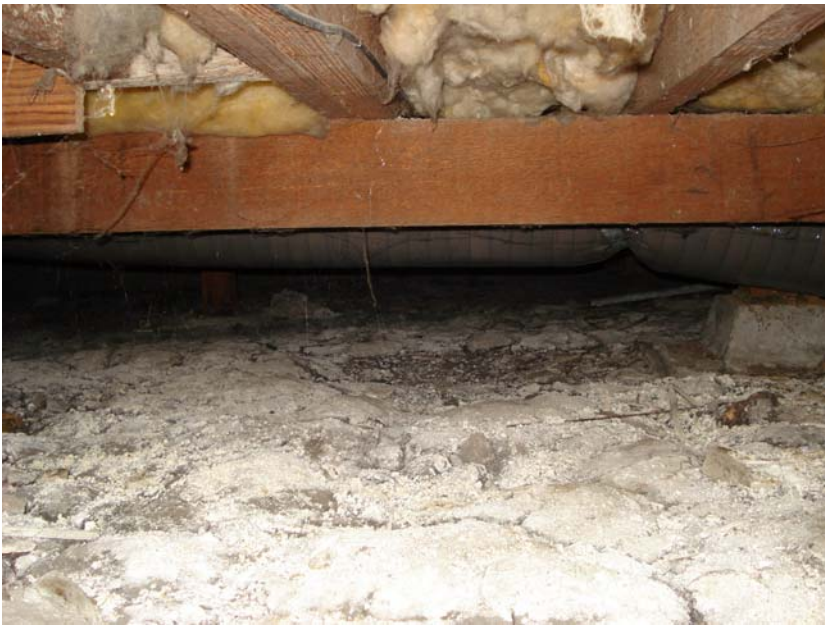
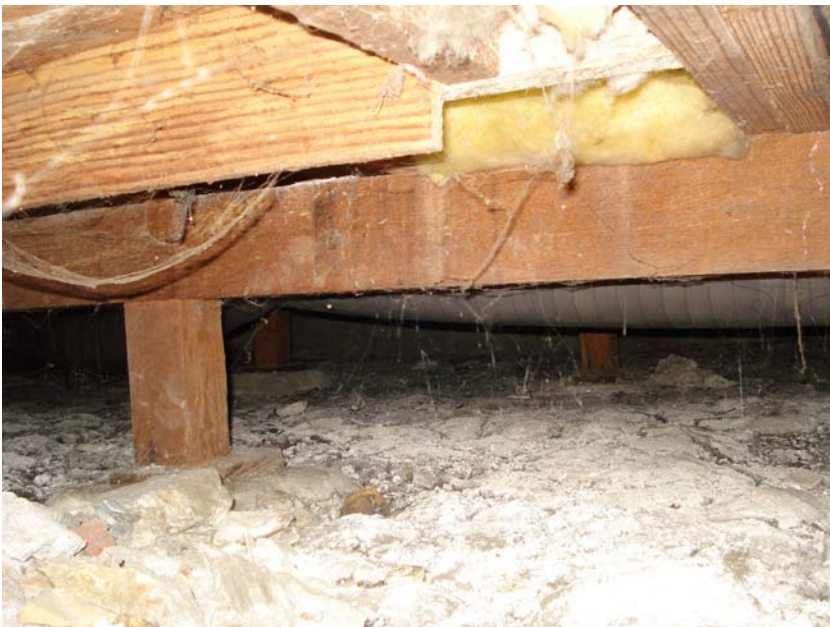
We inspected the crawl space and found substantial moisture in the soil, although the weather has been dry for many weeks. Our conclusion is that it is probable that moisture from the crawl space is entering the house through leaks in the floor. 60% and higher humidity levels are considered by many authorities unhealthy because they encourage the growth of mold and mildew on interior surfaces and respiratory infections in humans, and can contribute to the deterioration of building materials through termites and wet rot. While our measured level is a little below 60%, the humidity in your home likely exceeds 60% during less dry seasons. If you are not experiencing any of these problems, you might choose to ignore the issue of indoor humidity.

Ground under house was somewhat damp. This could be the source of moisture and cause higher than average humidity in the house.

If these problems do occur, you may want to consider the installation of a ground vapor retardant barrier on the ground in the crawl space. This should be thick reinforced polyethylene sheeting, such as Moistop Ultra 15, with the seams sealed with mastic and the edges sealed to the foundation walls and any pier blocks with mastic. A rugged material is less subject to puncture or tearing when people are working the crawlspace and is

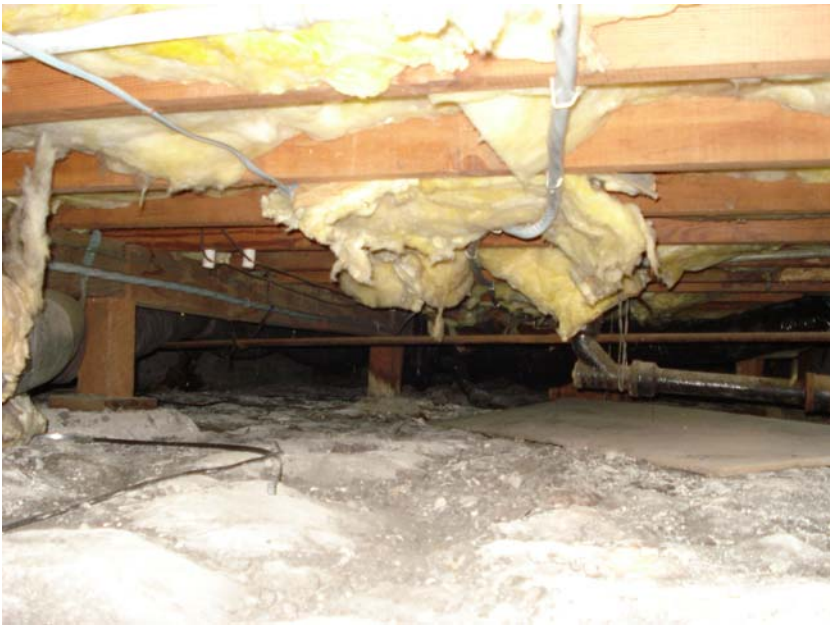
Note: Some areas the floor insulation has fell out. These could be repaired at the same time that a ground moisture retardant barrier is installed.

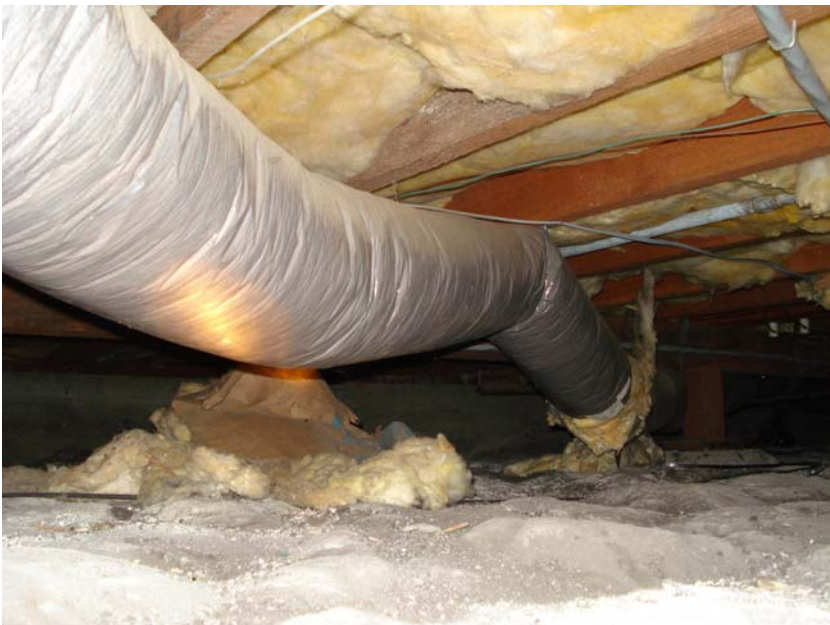
More fallen insulation.
