Home Energy Efficiency Report

Property Address: [REDACTED]

Date of Site Visit to Property: **August 20, 2009**

Site Visit and Report by: **Rick Meyer**, CHEERS® Certified Existing Home Analyst and
[REDACTED], Certified GreenPoint Rater

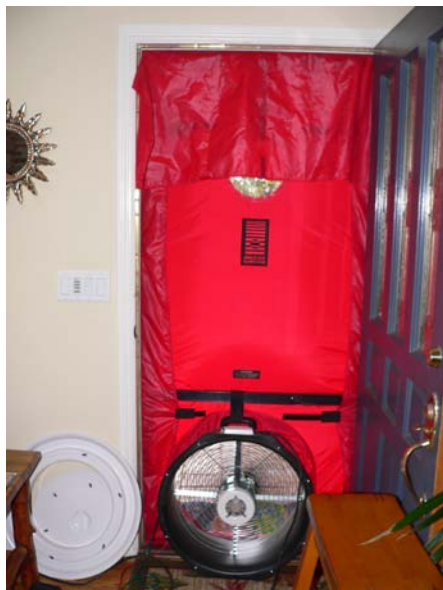
Blower door test underway

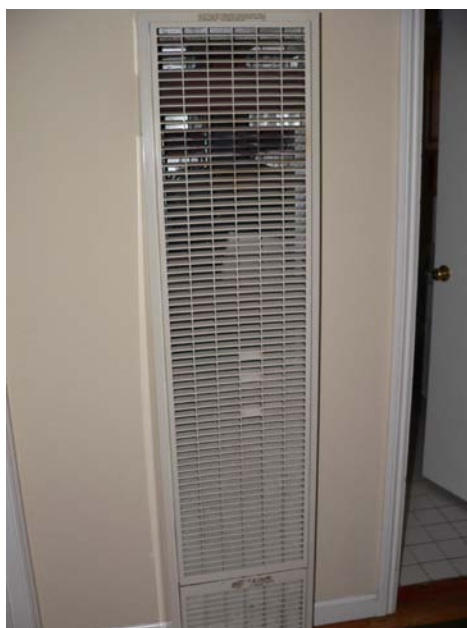
Your wall furnace has a low efficiency of about 65% AFUE efficiency and is obsolete and inadequate. We recommend that it be replaced with an Energy Star rated condensing central furnace or boiler with 90% AFUE or higher efficiency. Efficiency for the equipment is given as AFUE, the annual fuel utilization efficiency. If you follow our recommendations related to insulation and reducing building leakage first, you may be able to install a less expensive furnace with a lower heating capacity. It has been very common that HVAC contractors install oversized equipment and you should guard against this as such equipment is more expensive and runs less efficiently.

Williams wall furnace to be replaced.

8. Unless you plan to replace the old Williams furnace very shortly, we recommend installing a carbon monoxide sensor in an electrical outlet near the furnace in compliance with the manufacturer's directions. The typical mode of failure for this type of furnace is that holes corrode through the heat exchanger, releasing flue gas containing carbon monoxide into the home. Purchase an alarm that plugs into the wall and emits a loud alarm tone. These units cost about \$25- \$40 and are available at hardware and home improvement stores as well as online. Do not use an outlet protected with a ground fault interrupter (GFI). You can identify such an outlet by its two push buttons between the two outlets, usually marked Reset and Test.

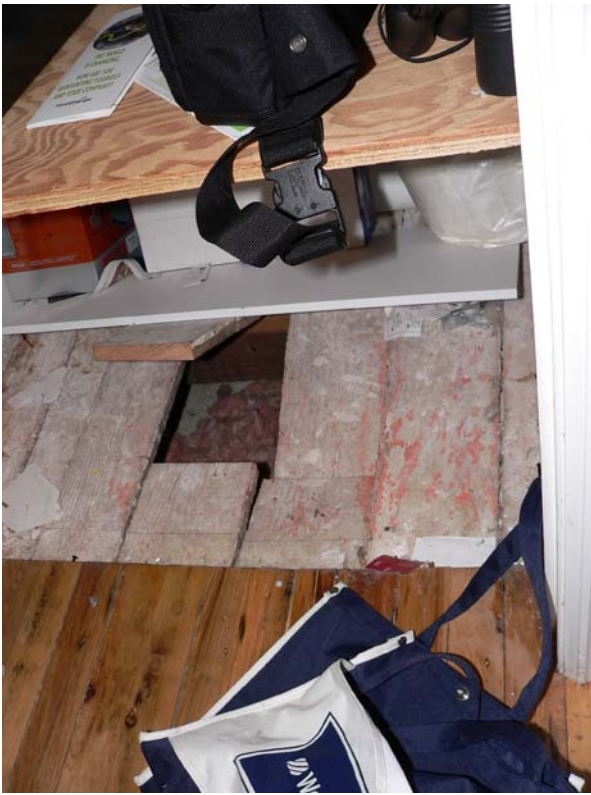
Hole in floor in Christian's office needs repair.

2. Repair the hole in the floor of the closet in Christian's office. The hole is a point of major air leakage and can provide entry into the living area for pests.
3. Crystal's office on the top floor gets hot in the summer. A lot of the heat gain is through the roof, and there is no easy access to add roof insulation, until the roof needs replacing. This would be an area where you might be able to experiment with adding a cool roof coating, as the roof has a low slope and is not visible from most vantage points. These coatings are relatively new and have not been tested for long periods of time, but accelerated independent aging tests have been conducted. The state of California has approved certain available cool roof coating products. We did not inspect this roof and do not know what material was used or whether coatings are compatible with the material.

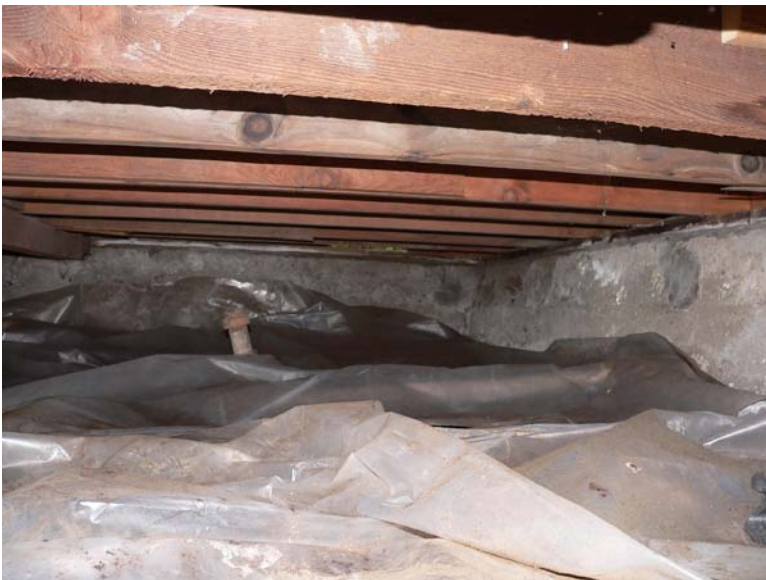
You reported prior humidity problems indoors, and these were partially addressed by laying down thin unreinforced polyethylene sheet. However, inspection of both crawl spaces showed that the sheet only partially covers the soil and it is not sealed anywhere to the foundation wall. We noted an area of mold growth on a pier block in the crawl space, indicating the moisture is beginning to degrade building materials. We recommend a more thorough examination of the crawl space to examine the condition of wood there by a performance contractor or the contractor chosen to install a moisture retardant barrier.

Polyethylene sheet in crawl space does not cover ground fully, is not sealed to foundation and will not withstand technicians working on it.

For these reasons we recommend, after confirmation through further humidity testing, the application of a better moisture retardant barrier on the ground in both crawl spaces, from 6 mil or thicker reinforced polyethylene. The edges should be sealed to the foundation wall and pier blocks with mastic or construction adhesive. Prior to installing the barrier, we recommend removing cellulose debris on the ground that can attract termites and any sharp objects that could puncture the barrier. Some building officials require that several inches of concrete remain exposed on the foundation and piers to facilitate inspection for subterranean termite tubes and that is our recommendation. We recommend monitoring the humidity in the home for a while after the vapor retardant barrier has been applied and the envelope has been sealed.

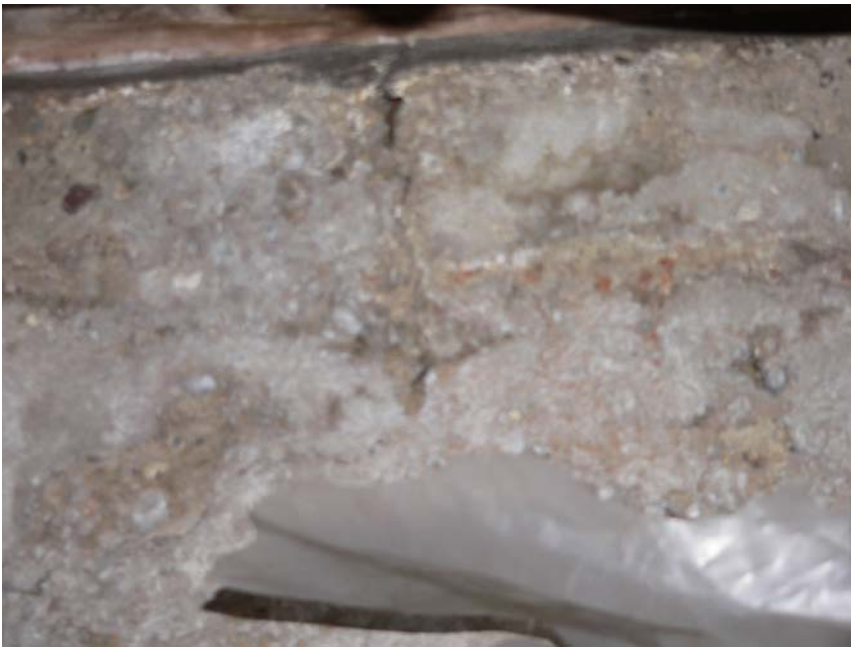
We found the soil damp in both crawl spaces, and you reported that a sump pump runs intermittently to drain the area, even during the summer. The foundation wall appeared to have no large cracks and no efflorescence. The foundation under the original portion of the house showed a considerable amount of voids, but no cracks. Clearances from the soil to the bottom of joists or beams ranged from about 14 to 16". There is no floor insulation. We saw no subterranean termite tubes on the inner foundation walls but recommend a more thorough termite inspection.

Foundation wall in old portion of house has voids, but no large cracks.
