Home Energy Efficiency Report

Property Address: **132 Van Ness Street**

Date of Site Visit to Property: **July 9, 2009**

Site Visit and Report by: **Sharon Block**, CHEERS® Certified Existing Home Analyst,
HERS Whole House Energy Rater, Certified GreenPoint® Rater, LEED AP and
Rick Meyer, CHEERS® Certified Existing Home Analyst

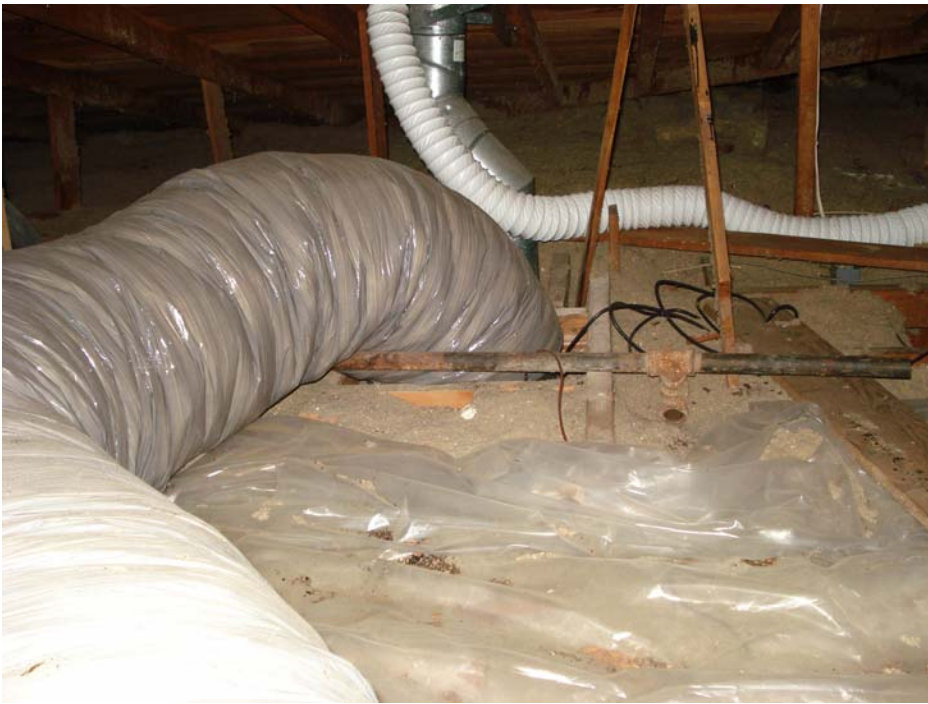
We recommend removing the plastic that covers the attic insulation to prevent the trapping of moisture.

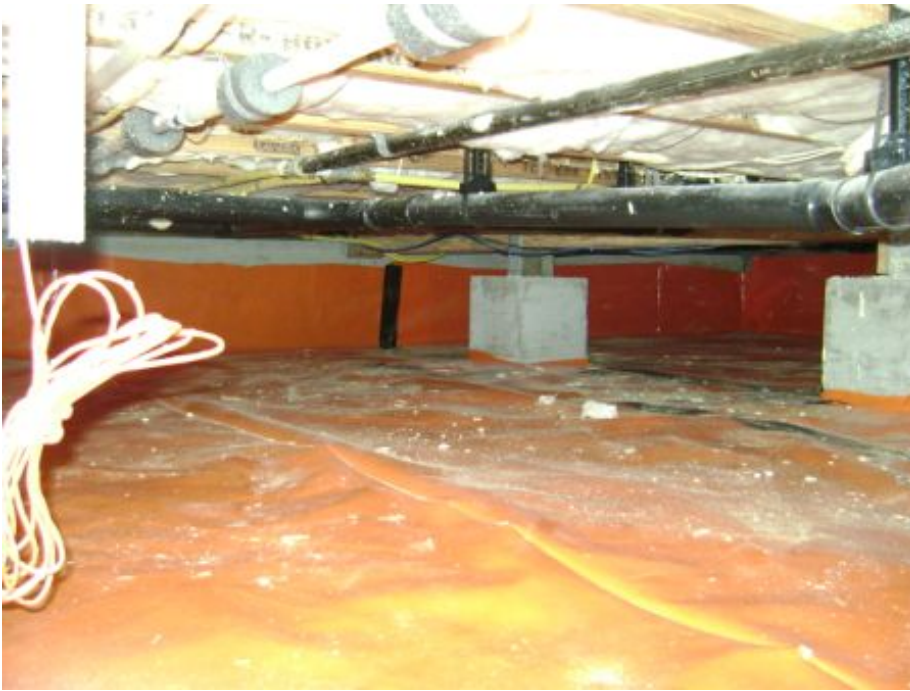
This example (not a photo of your house) has a ground vapor retardant barrier made from 15 mil thick MoistStop Ultra. All joints are taped. The edges of the polyethylene are sealed to the foundation wall and taped around pier blocks.
